Phase 1 Desk Study

Land rear of The Hollies, Reading Road, Burghfield Common, Reading, Berkshire, RG7 3BH

On behalf of Ta Fishers & Sons Limited

Report Reference: GWPR4464/DS/October 2021			Status: Final
Issue	Prepared By	Checked By	Verified By
v.1.01	[REDACTED]		
	Anna Smaje BSc (Hons) Engineer	Miltiadis Mellios MSc(Eng) GMICE Principal Engineer	Francis Williams MGeol (Hons) FGS CEnv AGS CGeol Director

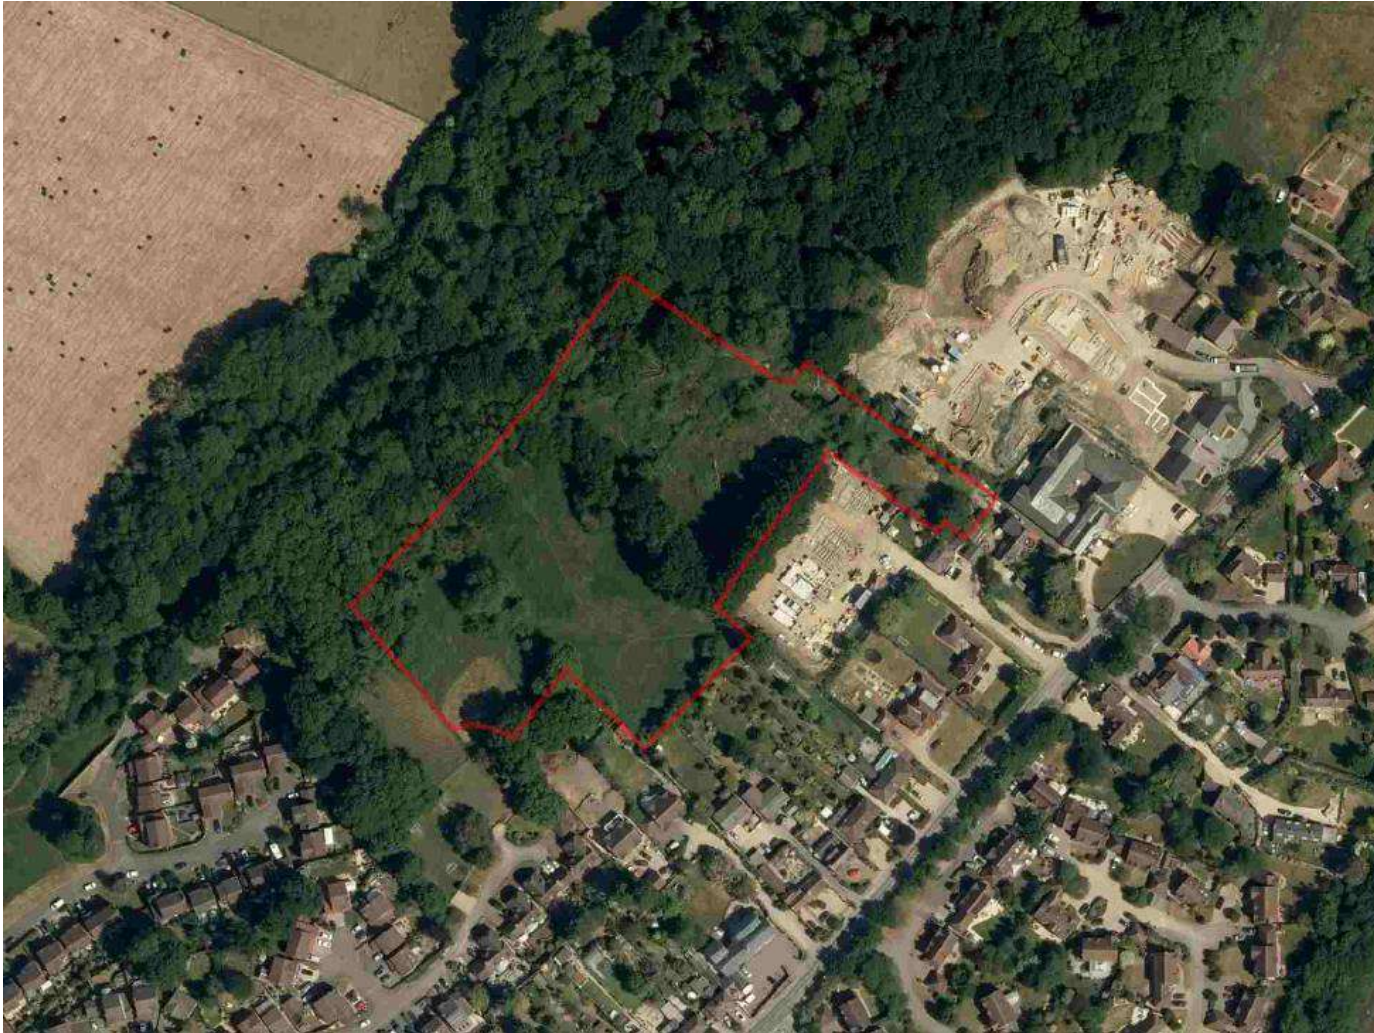
Figure 3 – Aerial View of the Site

Site Boundary

A Site Walkover was undertaken on the 15th October 2021. A description of the site, as noted during the Site Walkover, is tabulated below. An aerial view of the site, showing an approximate site boundary, is given within Figure 3.
