# EAGLE QUARTER II NEWBURY

## GROUND INVESTIGATION REPORT

Proposed Redevelopment  
The Kennet Centre  
Newbury

**GROUND INVESTIGATION REPORT**

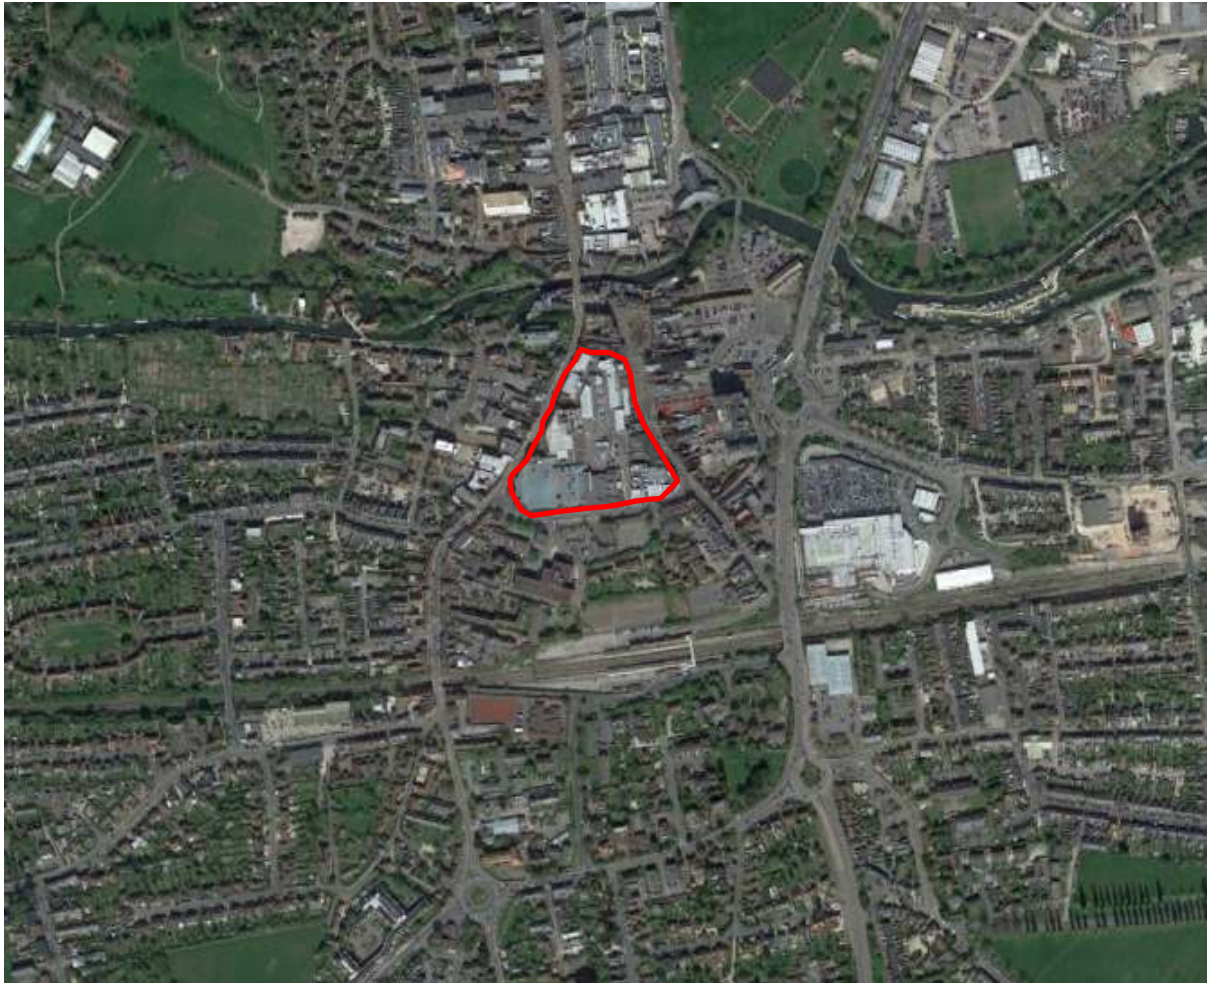
## Aerial photograph of site

Approximate area of site outlined in red.
